## Case Study Bath Probation

Damp-proofing to internal wall

Bath Probation Office, is a probation contact centre, within the South West region.

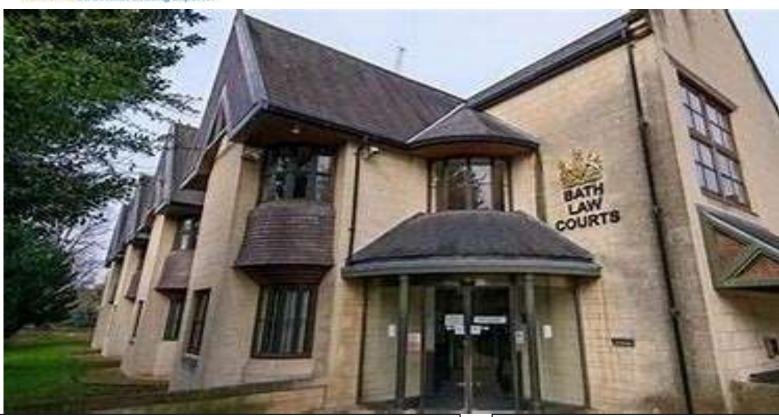
SWS were appointed to provide waterproofing installation to the building wall that had traces of visible damps

Survey investigation was carried out by stripping out false wall and exposing thr face of the block wall.

A combined system was adopted using Type A+C waterproofing system on the wall for damp-proofing purpose.

Dry rods were installed on the wall at low level 200mm above floor level and spaced at 200mm c/c. Cementitious screed was applied on the wall prior to cavity mesh membrane installation.
